Sidewall Cord Impact Break (Bubble)

NEXEN TIRE

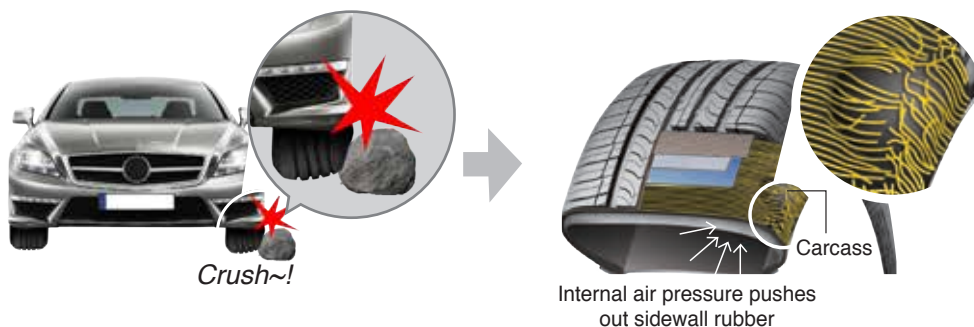
The carcass contains textile cord topping layers between steel belt and inner liner. If the textile cords of carcass are damaged due to sudden impact with a road hazard or a pothole, the sidewall of tire may arise like bump. This is why the internal air pressure pushes the surface through the gap in the cord. This is called Cord Impact Break(Bubble).
