Sidewall Cord Impact Break (Bubble)

NEXEN TIRE

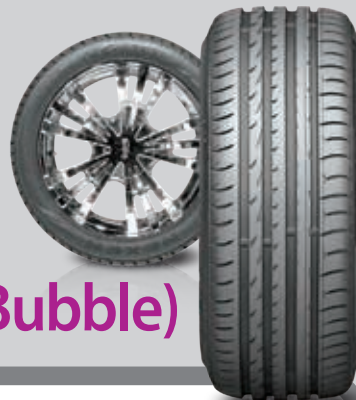
The carcass contains textile cord topping layers between steel belt and inner liner. If the textile cords of carcass are damaged due to sudden impact with a road hazard or a pothole, the sidewall of tire may arise like bump. This is why the internal air pressure pushes the surface through the gap in the cord. This is called Cord Impact Break(Bubble).

Impact damage such as curb / pothole

Localized protrusion in the sidewall

⚠ It is very dangerous to drive in the condition of cord impact break.

Avoid tread surface cuts and pothole impact if possible.

Drive on harsh bumpy road at low speed.

Maintain proper tire inflation pressure.

Check the tire for damage frequently.

Avoid contact with curbs.
